Visual Inspection and Health Appraisal
Of
Trees
Adjacent to
Stratton Playing Field/Play Area

Commissioned By:
Stratton Parish Council

Completed By:
Alan Goldstone
AG Tree Services Ltd
10a Knighton Lane
Broadmayne
Dorset
DT2 8EZ

Date of Report:
4th February 2019

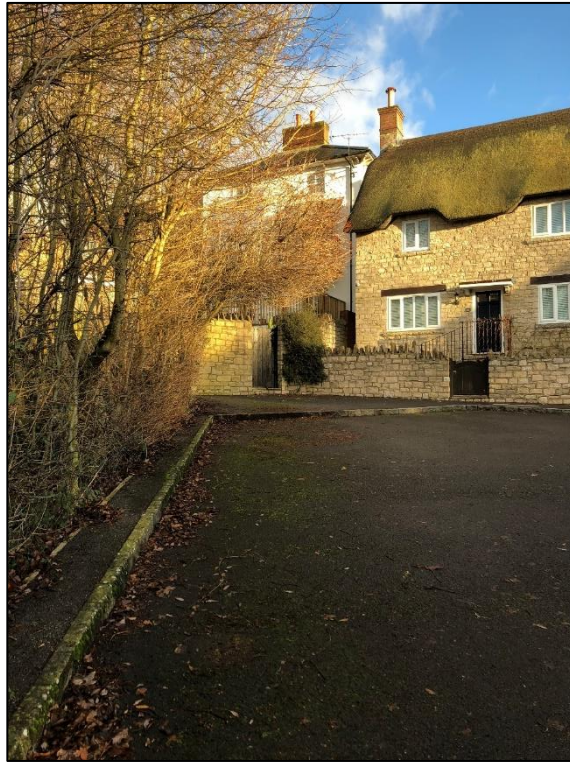
The canopies of the mixed shrubs and Oak (*Quercus* sp.) tree (Plate 2) at either end of the car parking area are drooping low over the end spaces.

Plate 2 – Overhanging canopies of the parking spaces

Dorset Highways stipulate that a 2.2m minimum clearance from trees, hedge and shrubs must be present over a pedestrian area and 5.2m over a highway. The car parking area in Penn Hill View would technically be called as highway but a 5.2m would be excessive given that no lorries need to pass below it. It is there for recommended (required) that the oak trees and mixed shrubs are pruned to a height of 2.7m over the car parking area. This gives the 2.2m required for pedestrian areas and a 0.5m buffer to allow for regrowth. It will also ensure that sufficient height is achieved to allow taller vehicles (vans) to park in this area without being struck by the overhang.

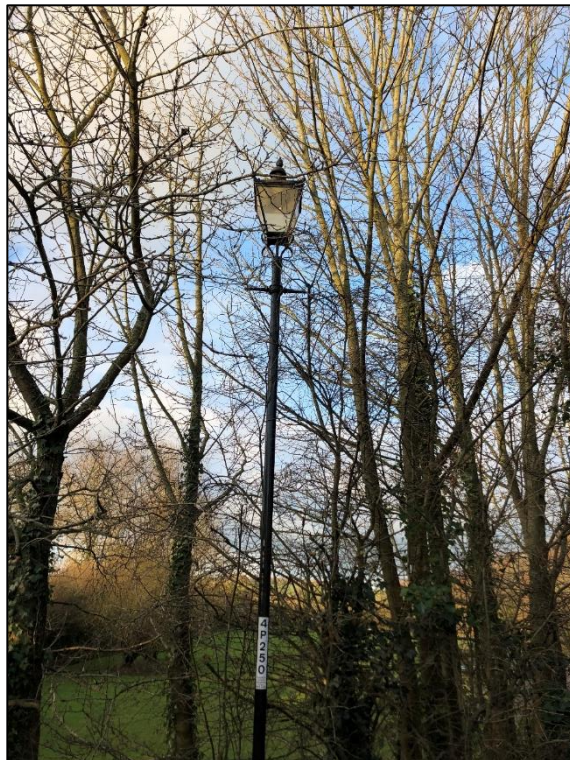
The street light is currently being obstructed by branches (Plate 3).

Plate 3 – Streetlight obstructed by branches

Dorset Highways further stipulate that street lamps must be clear of vegetation, ensuring that a tapered clearance is also obtained to ensure that the lamp can illuminate an area below it.

It is therefore recommended (required) that the Street Lamp is cleared similar to the guidance shape given in Plate 14, which was taken from Dorset County Councils guidance leaflet.

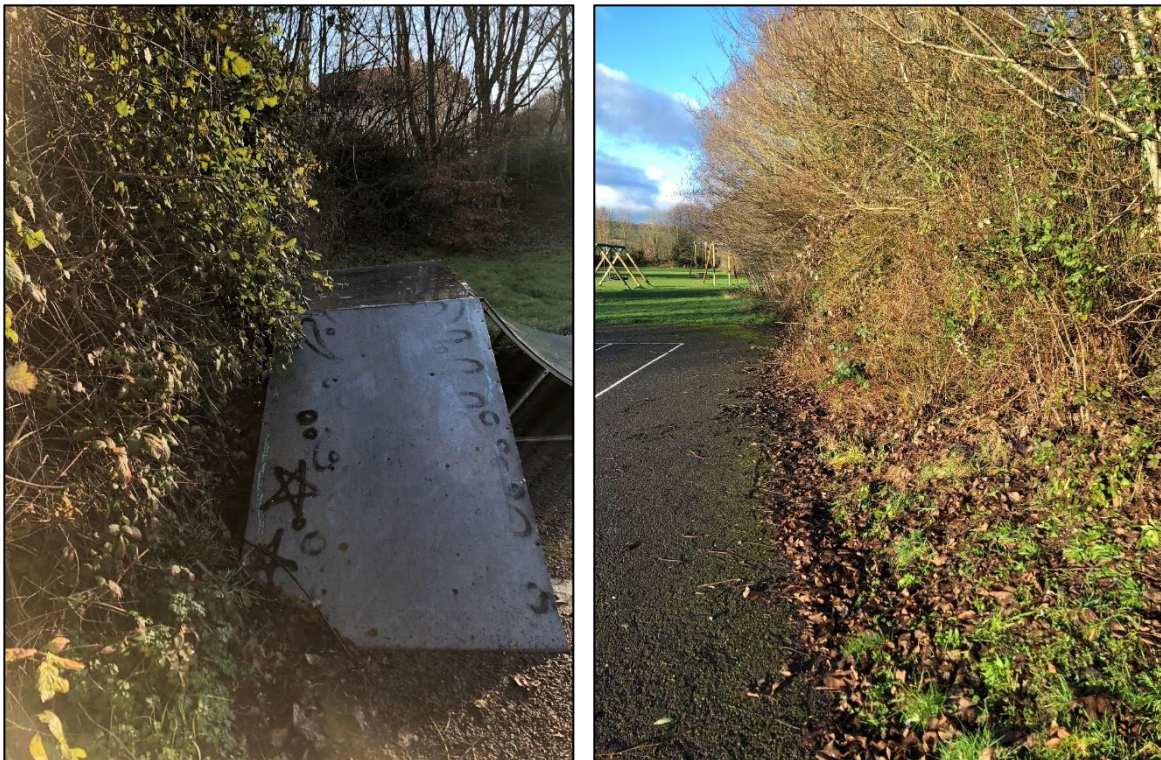
There is considerable overhang of vegetation, largely bramble, encroaching onto the ramp and hardstanding play area (Plates 4 & 5).

Plates 4 & 5 – Vegetation encroaching onto ramp and hardstanding play area

The vegetation overhanging the play area poses a risk of injury to the children likely to be using it in the form of scratches, splinters and potential eye injuries. It is recommended (required) that this vegetation is trimmed back from the hardstanding edge. A 2m clearance buffer is suggested to ensure the regrowth can also be kept off the play area.

It is worth noting that bramble provides an excellent food source for small mammals and birds and as such, should not be eradicated from the site. It is however a vigorous growing species which can be deemed invasive so it is important (preventative) that the amount of bramble in this area is monitored and maintained accordingly in future grounds maintenance programmes.

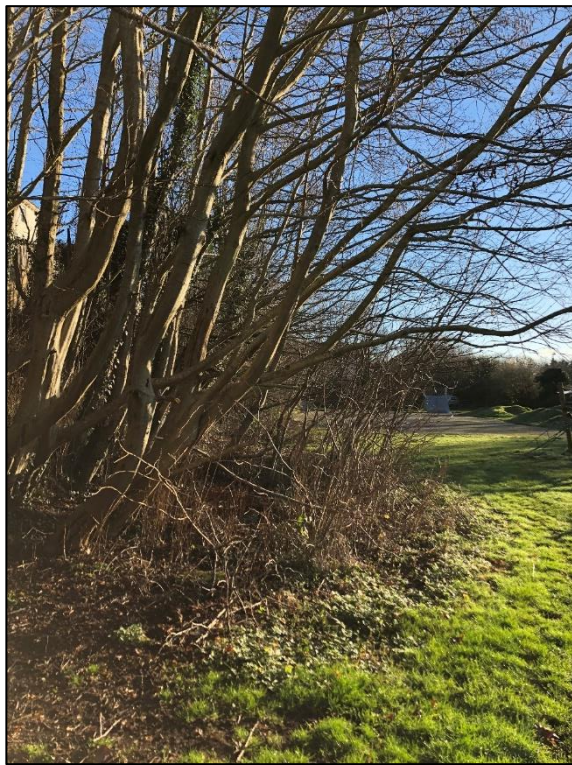
Area 3a, depicted on the map diagram in Section 4 of this report and circled in red, has heavily leaning alder stems growing over the grass play area due to phototropism (Plate 6) and many have mammal damage on the stems which is probably caused by grey squirrel (Plate 7).

Plate 6 – Heavily leaning alder stems in area 3a

It is recommended that the worst of the overhanging vegetation in Area 3a is removed (preventative) and that the saplings are thinned out favouring the cherry trees. This will encourage the remaining trees to grow straighter.

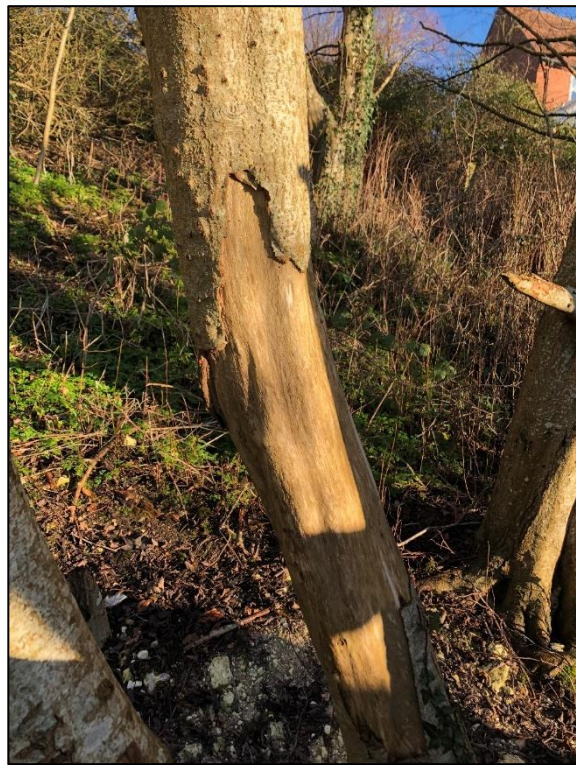
Plate 7 – Example of mammal (squirrel) damage

The worst of the squirrel damaged stems should also be removed (preventative) as the removal of the bark is likely to have allowed the ingress of decay to occur which is expected to cause issues in the near future.

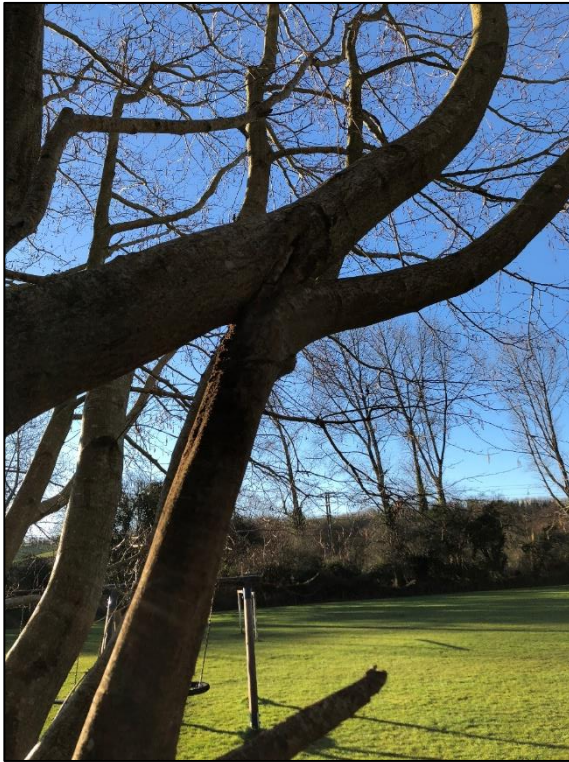
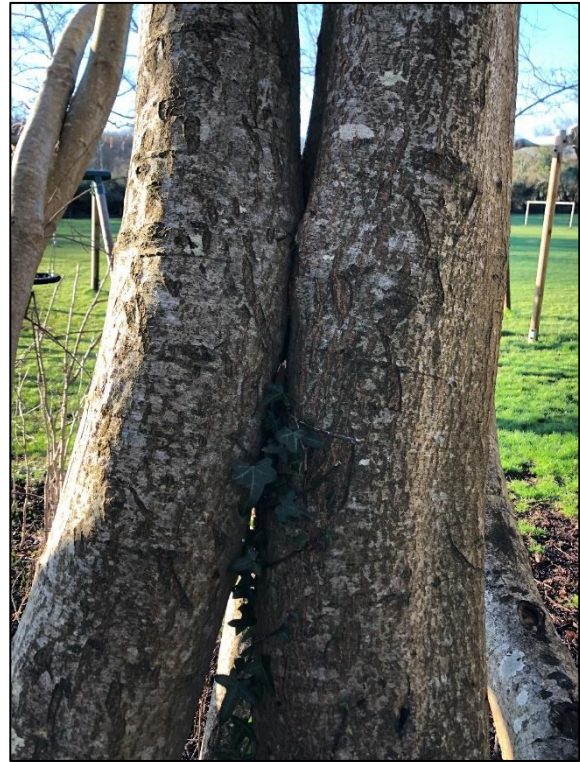
There were at least three stems touching or crossing in Area 3a (Plates 8 & 9).

Plates 8 & 9 – Examples of the touching and crossing branches in Area 3a

The crossing and touching stems are also likely to cause issues in the near future as there is insufficient room to allow incremental growth. This should be addressed (preventative) by removal of one or both affected stems (depending on the quality of the stems involved).

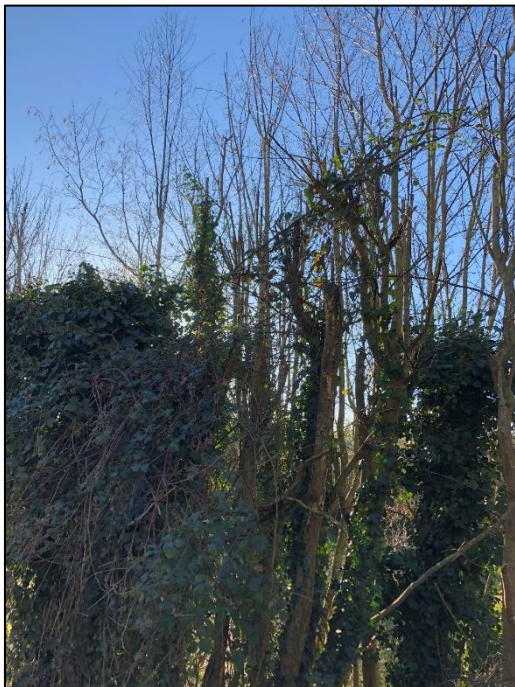
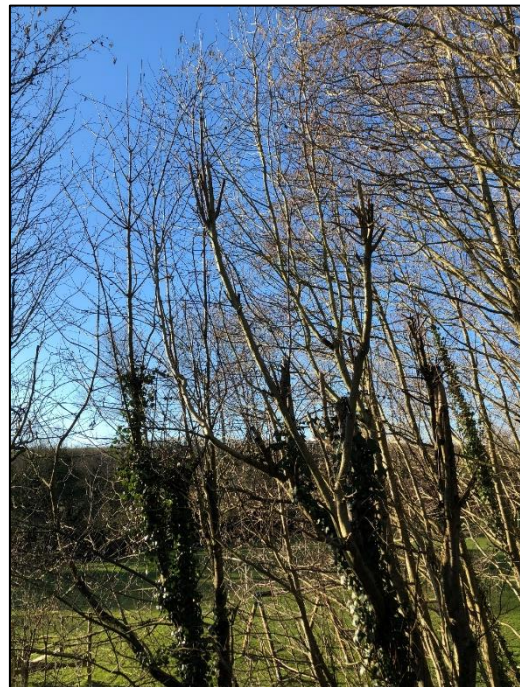
A number of trees directly behind 7 Church View have been ‘topped’ in recent years. These trees are dead (Plates 10 & 11).

Plates 10 and 11 – The ‘topped’ dead trees behind 7 Church View

It is not clear whether the pruning of the trees behind 7 Church View had been carried out with the permission of the Parish Council but as it has almost certainly contributed to the fatality of the trees in this area. It should be made clear to local residents that this practice is not acceptable (and unlawful if carried out without the landowner's permission) and should cease immediately. Due to the dead trees' location at the top of the slope and their size, they are not deemed to present a significant risk and can be retained as standing deadwood habitat.

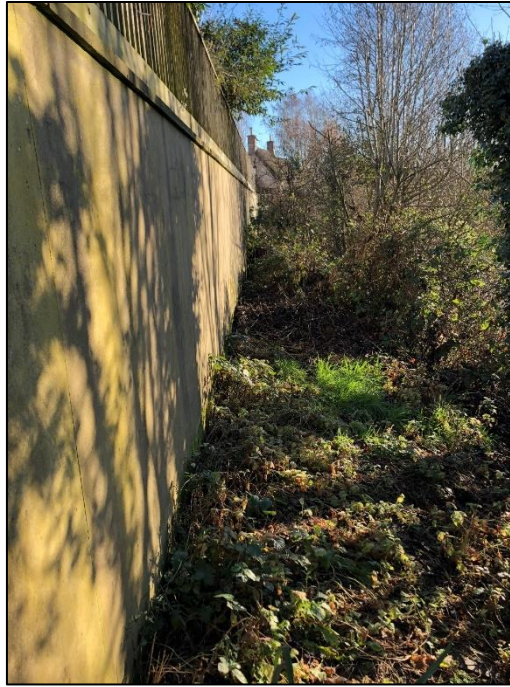
There was very little vegetation noted in close proximity to the high boundary wall (Plate 12).

Plate 12 – The vegetation close to the wall

The area of vegetation growing in close proximity to the wall is minimal but to ensure that good airflow is maintained (thus preventing any damp issues attributable to the vegetation) it is recommended (preventative) that a 2m clearance buffer of vegetation is removed along the length of the wall and maintained as part of any future grounds maintenance programme.

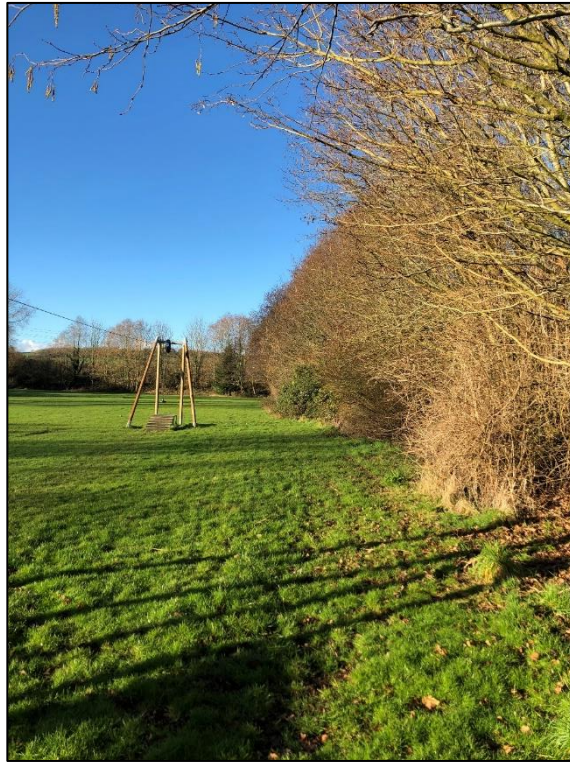
There is a thick patch of bramble noticeably overhanging the grass playing field area (Plate 13).

Plate 13 – Overhang in Area 4

It is recommended that consideration is given to removing the worst of the overhanging trees/large shrubs along the playing field edge in this Area (preventative). This will stop any heavily leaning stems growing out over the playing fields as a result of phototropism.

It is also recommended (preventative) that the large clump of bramble is managed as part of future grounds maintenance to stop it spilling into the playing fields and to prevent it becoming invasive and stopping other vegetation from establishing.
