Annex D – Tree Photographs

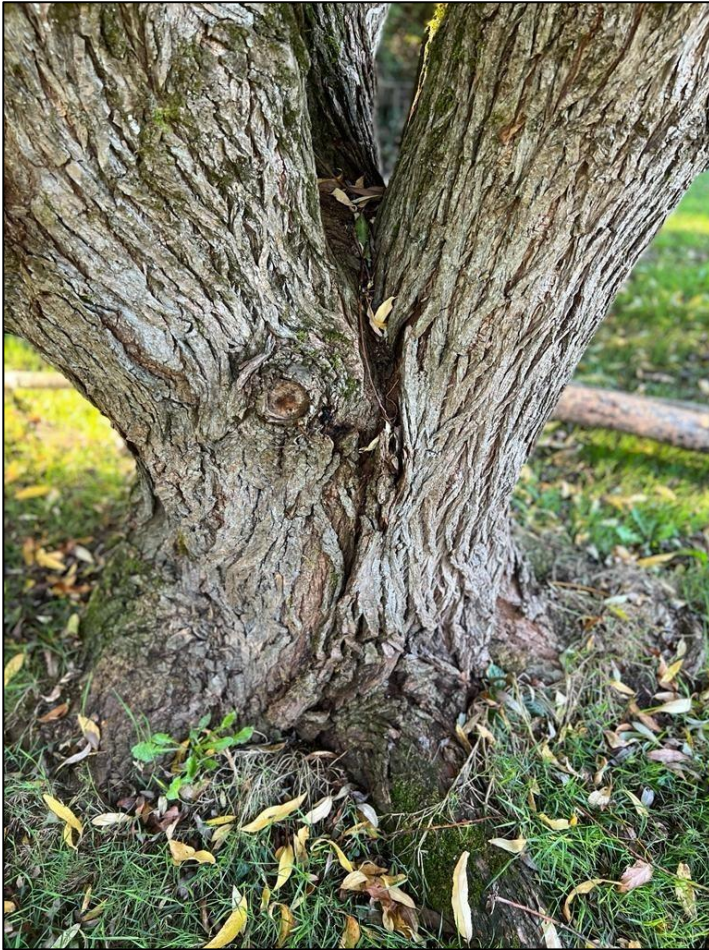
Photo 1 – Compression fork on willow tree (T1)

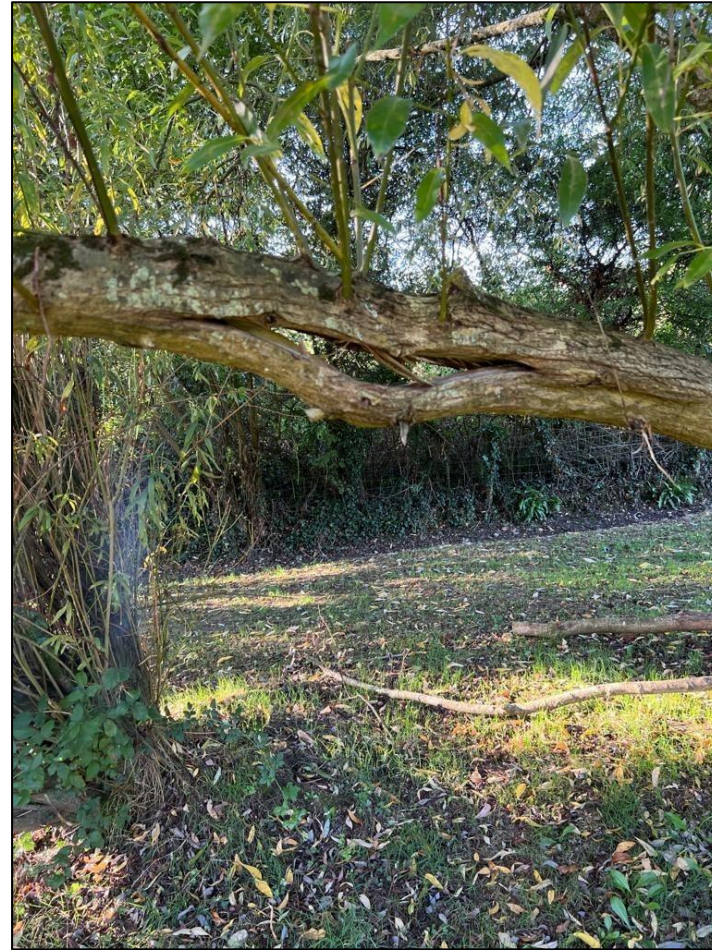
Photo 2 – Sheer fracture on long hazard beam

Photo 3 - Leaning willow scrub under the willow tree (T1)

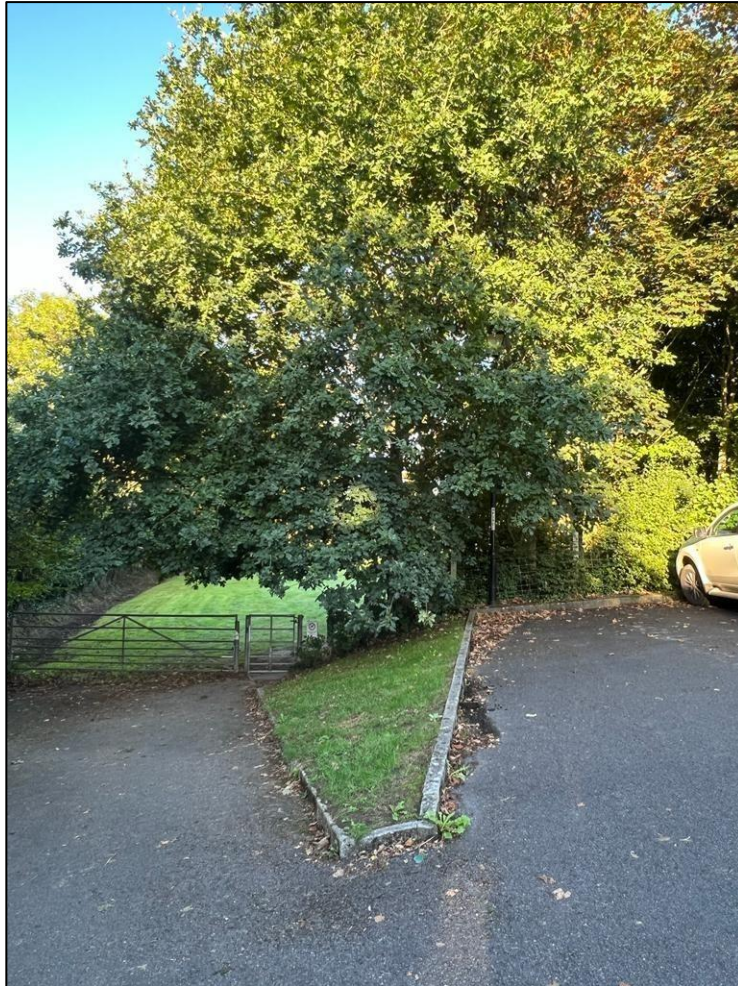
Photo 4 – Overhang over the parking area from G1

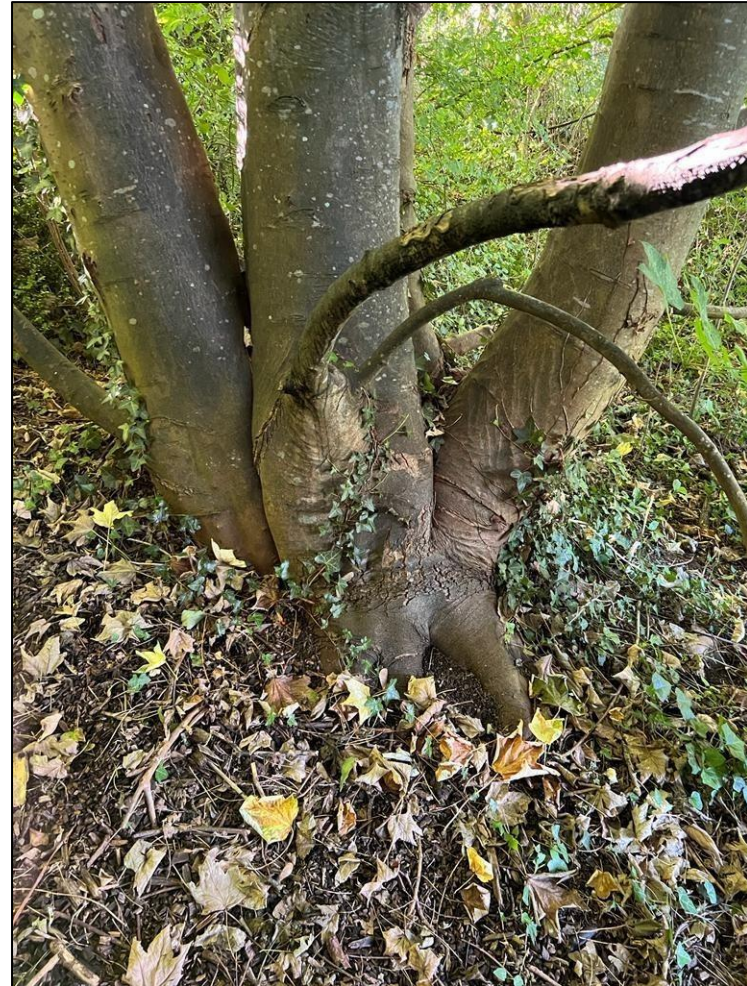
Photo 5 – The overhang over the parking area and field entrance (G1)

Photo 6 – Compression fork on G2

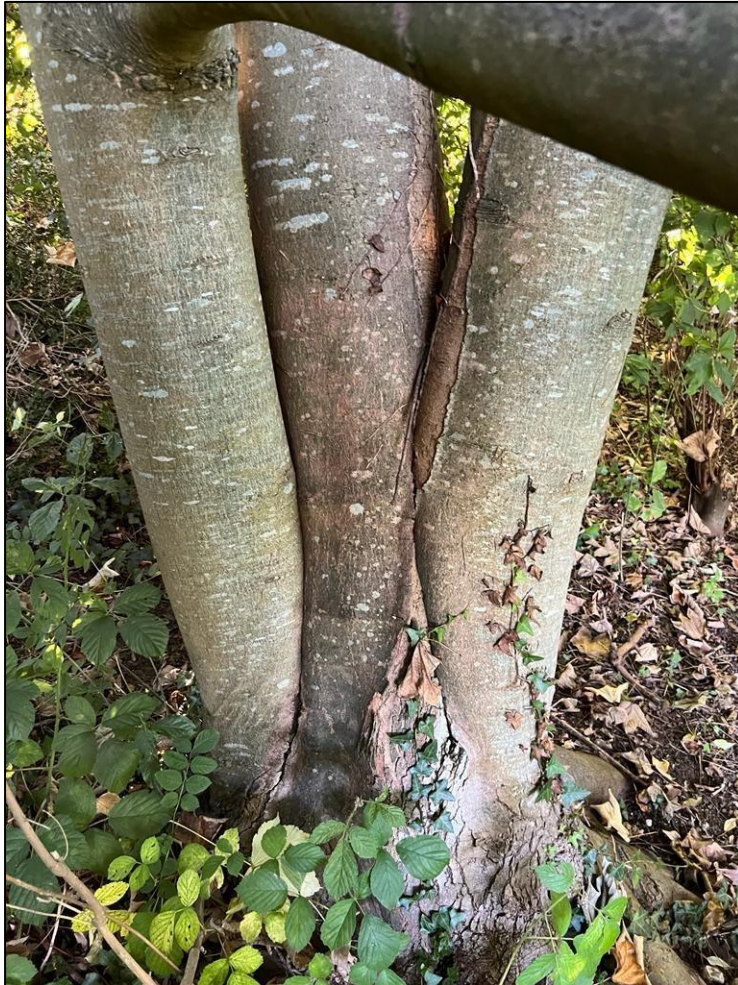
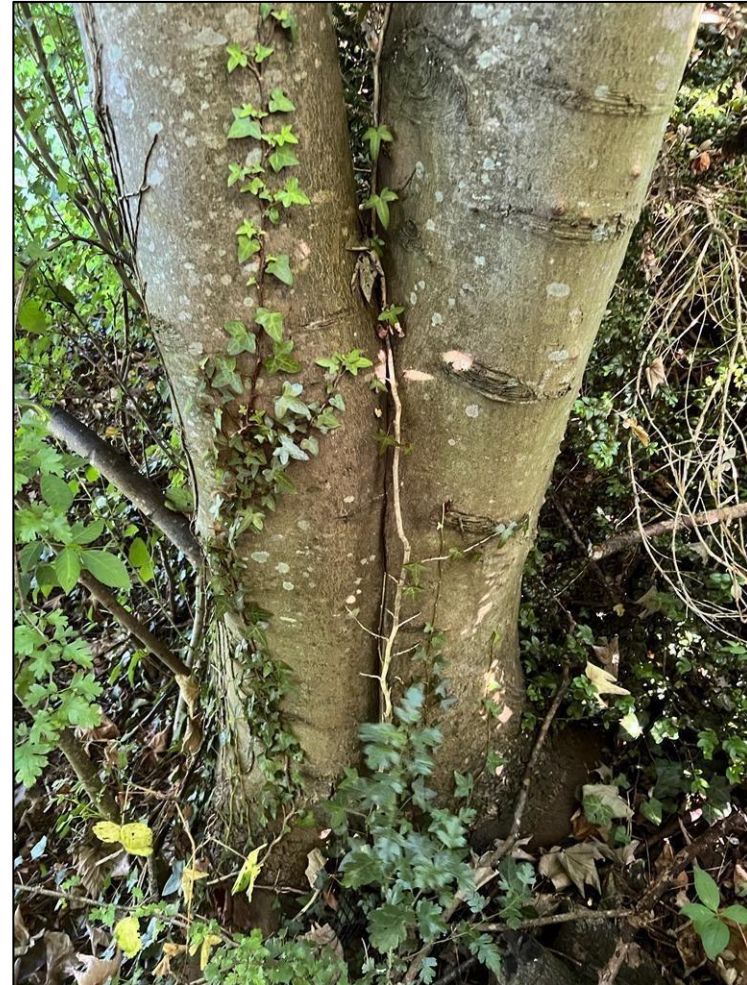
Photos 7 & 8 – Compression forks on G2

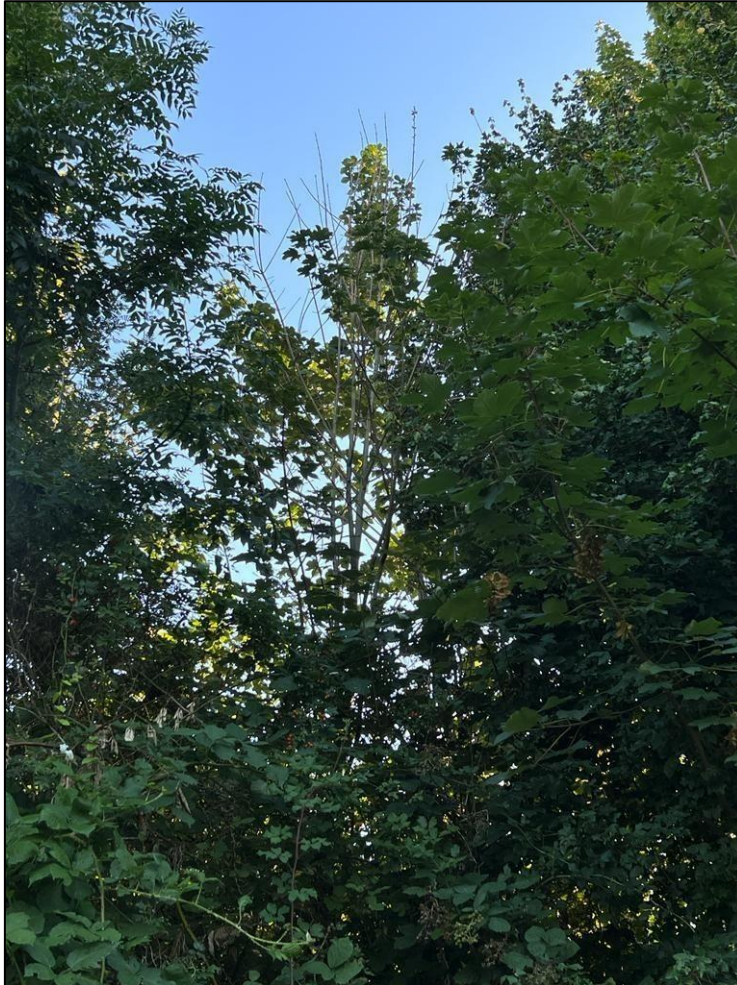
Photo 9 – Standing dead ash tree (T2)

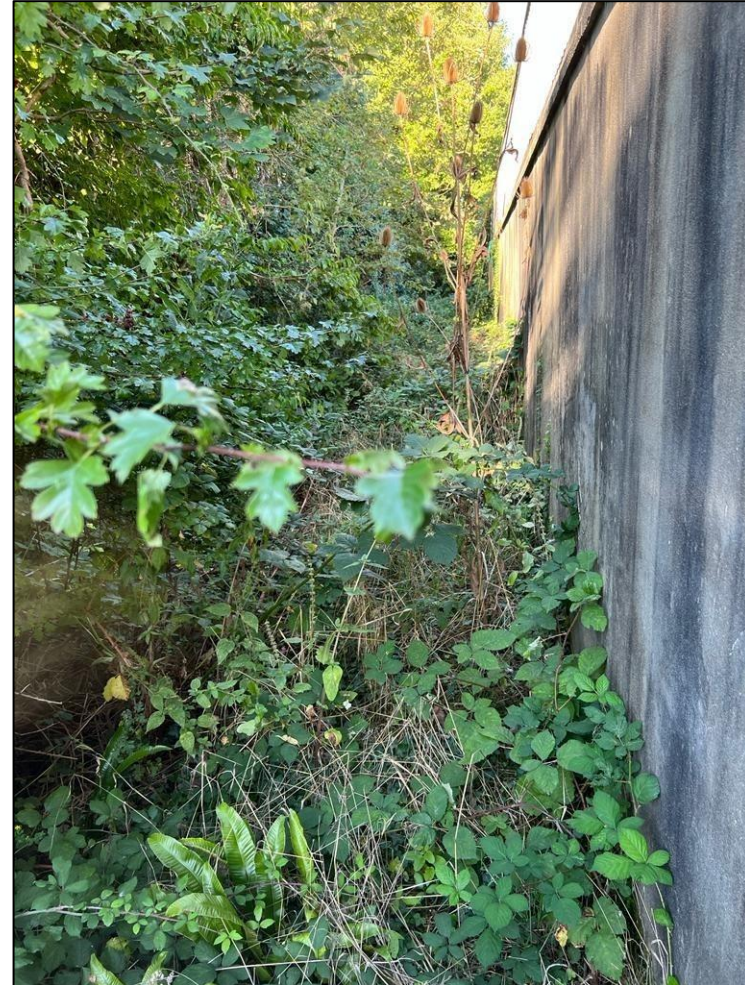
Photo 10 – Vegetation next to retaining wall (G3)

Photos 11– Vegetation next to retaining wall (G3)

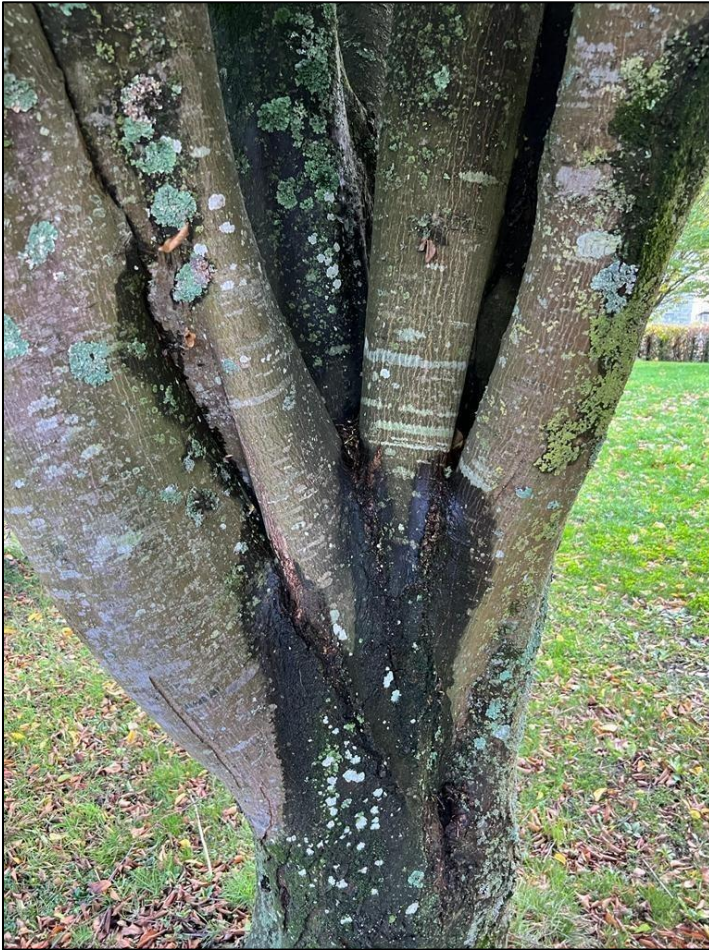
Photo 17 _ Compression fork on hornbeam (T6)

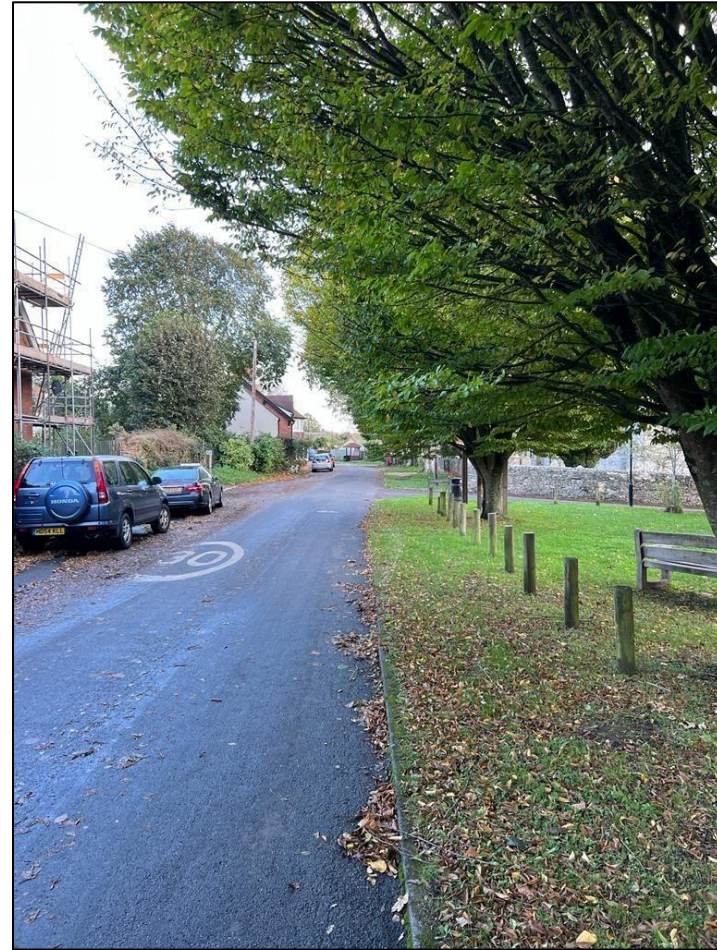
Photo 18 _ Branches impinging the highway along Dorchester Road

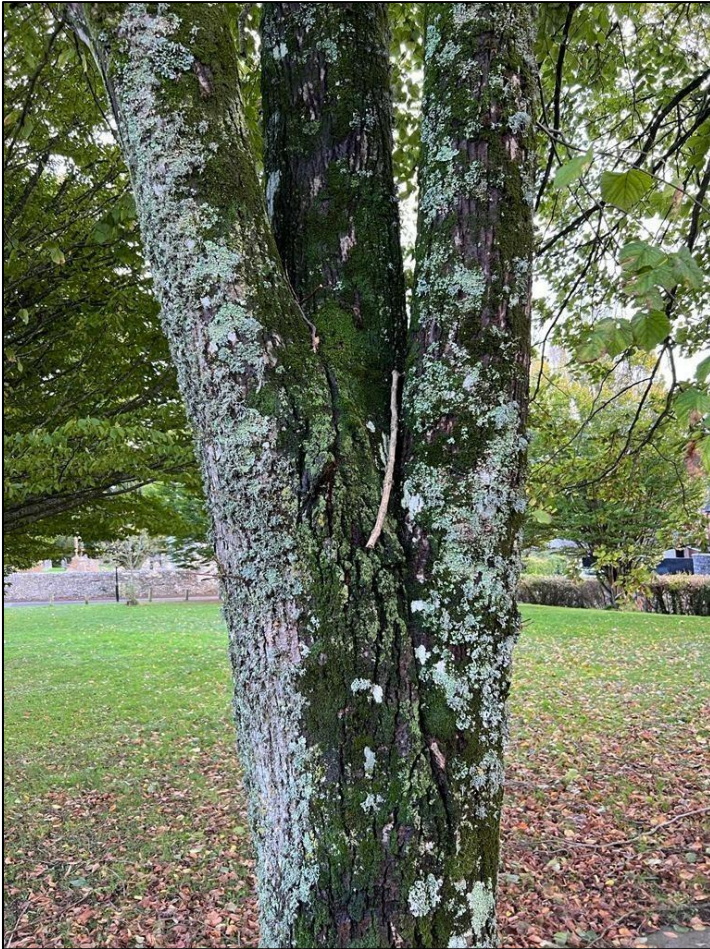
Photo 19 – Compression fork on Lime tree (T8)

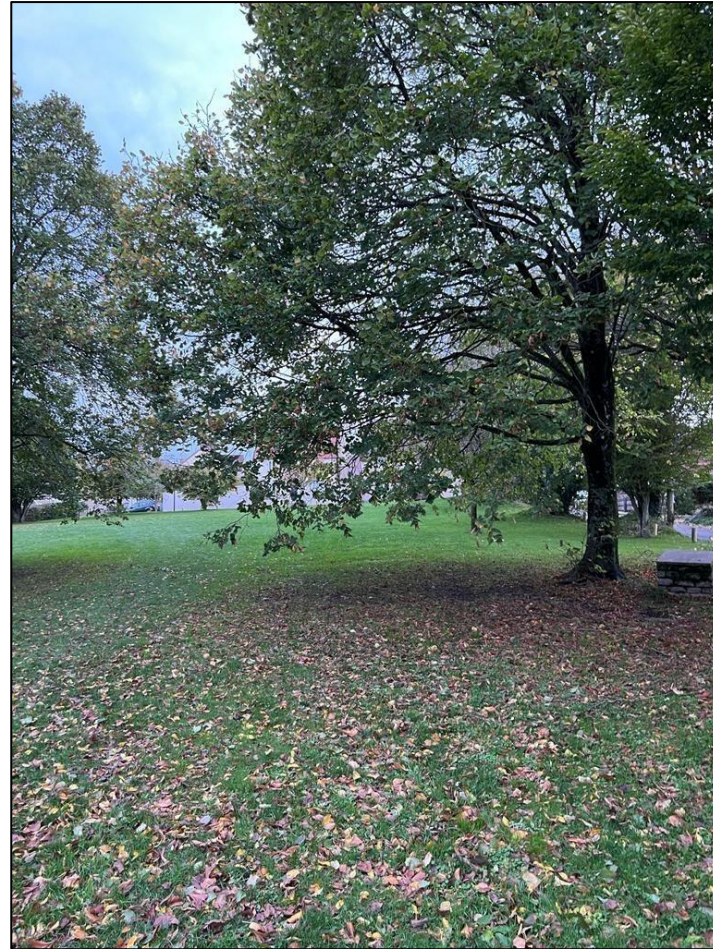
Photo 20 – Crown raise required on lime tree (T9)

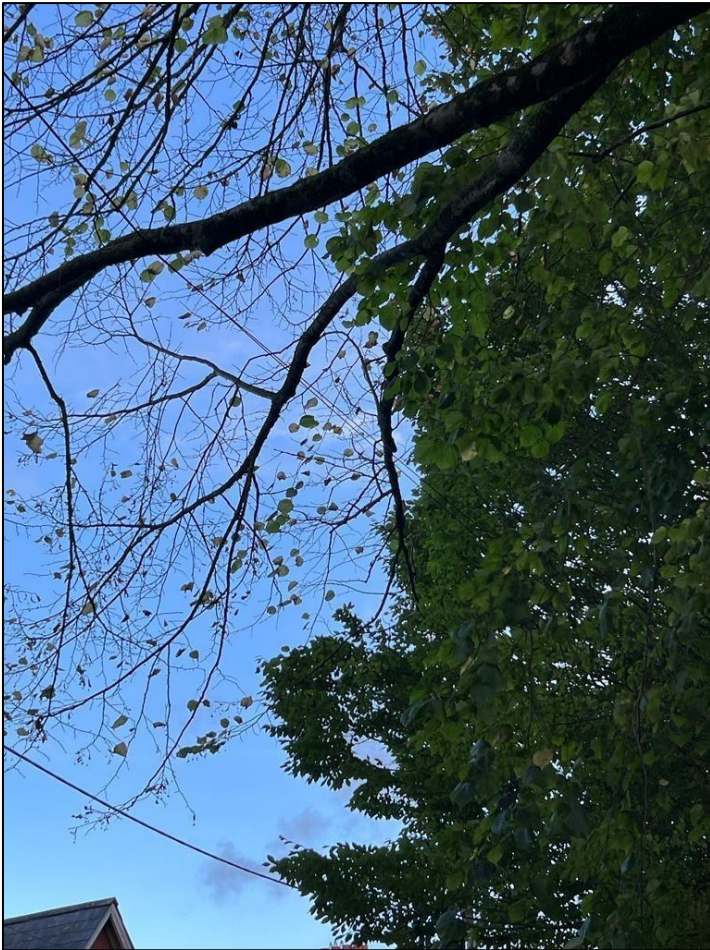
Photo 21 _ Branch pushing on cable on lime tree (T10)

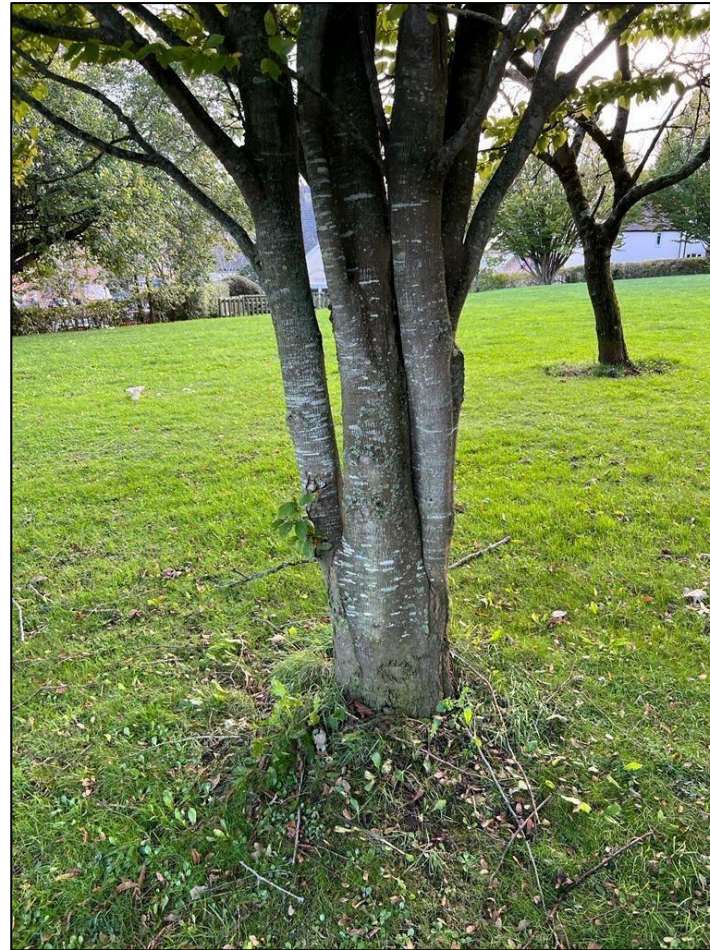
Photo 22 _ Compression forks on hornbeam (T11)

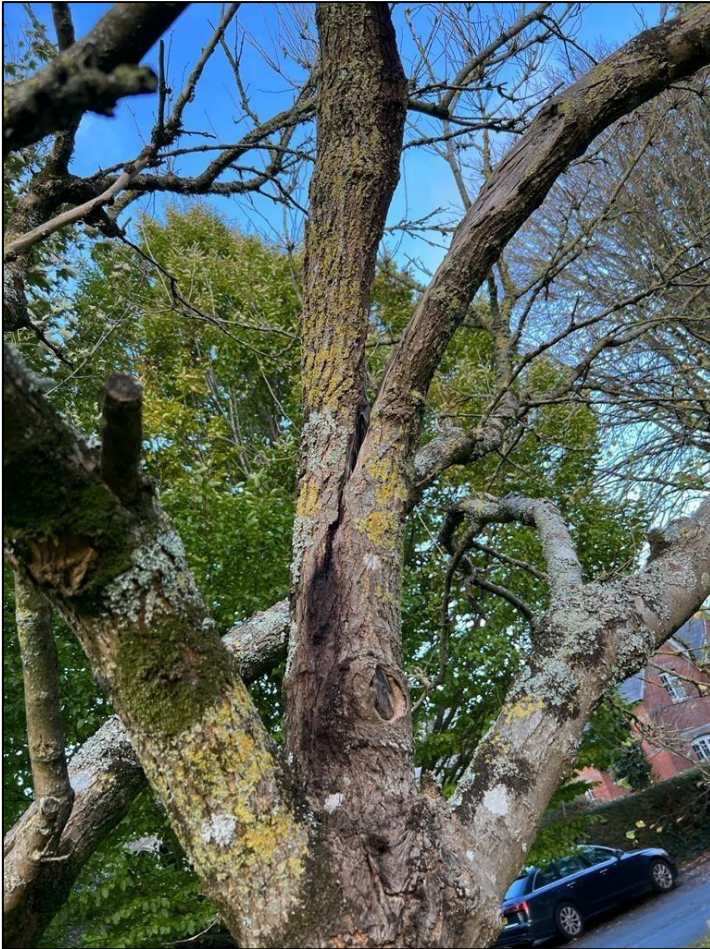
Photo 23 _ Failed union on potentially dead tree (T12)

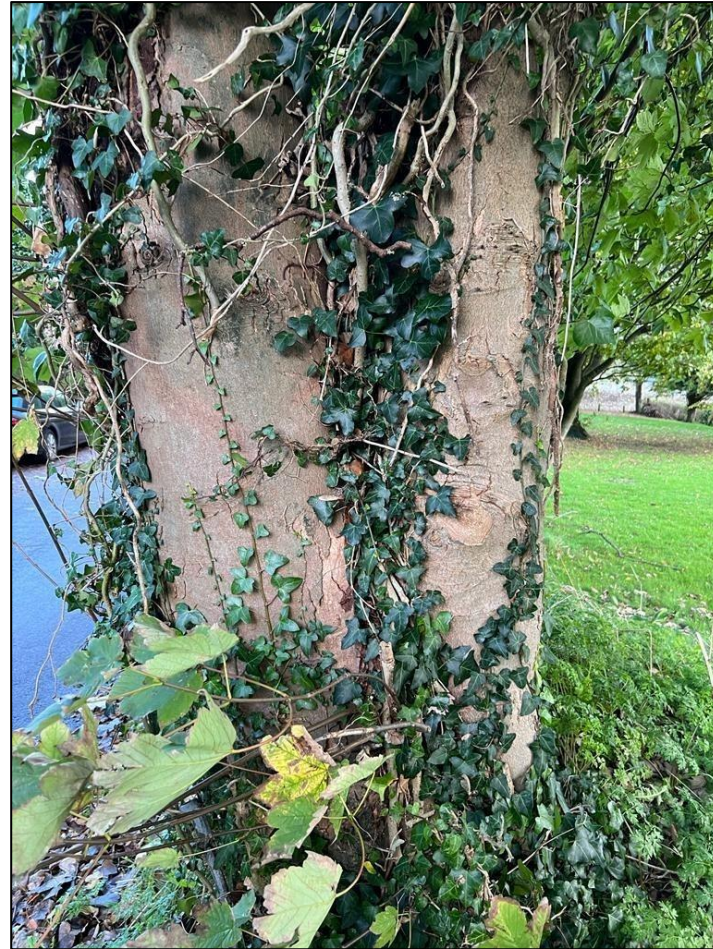
Photo 24 _ Ivy covering compression form on sycamore tree (T13)

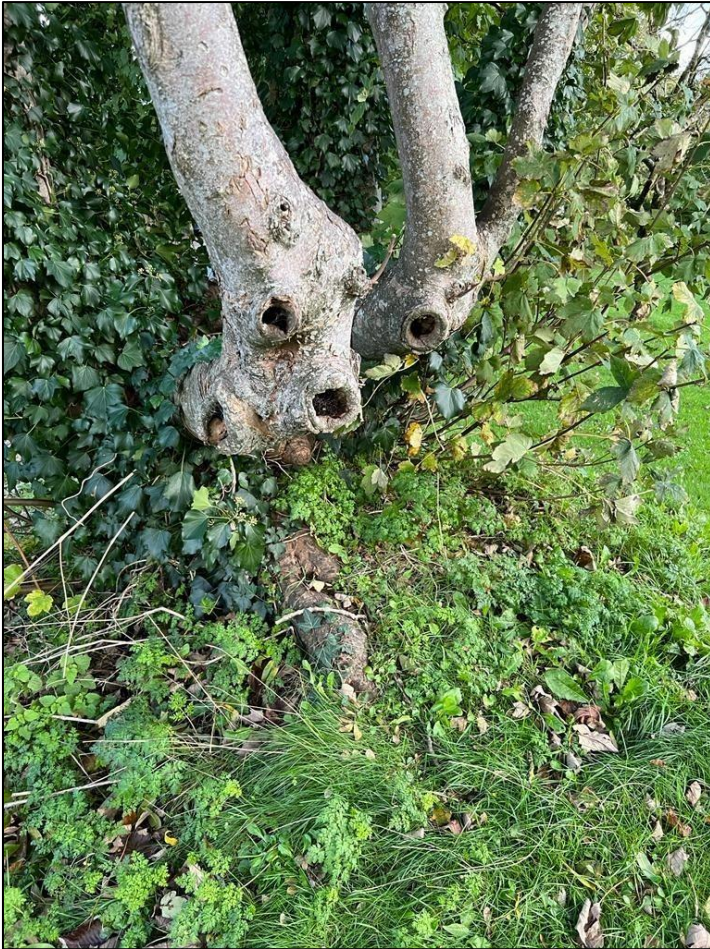
Photo 25 _ Hazard beam cavities on sycamore tree (T14)

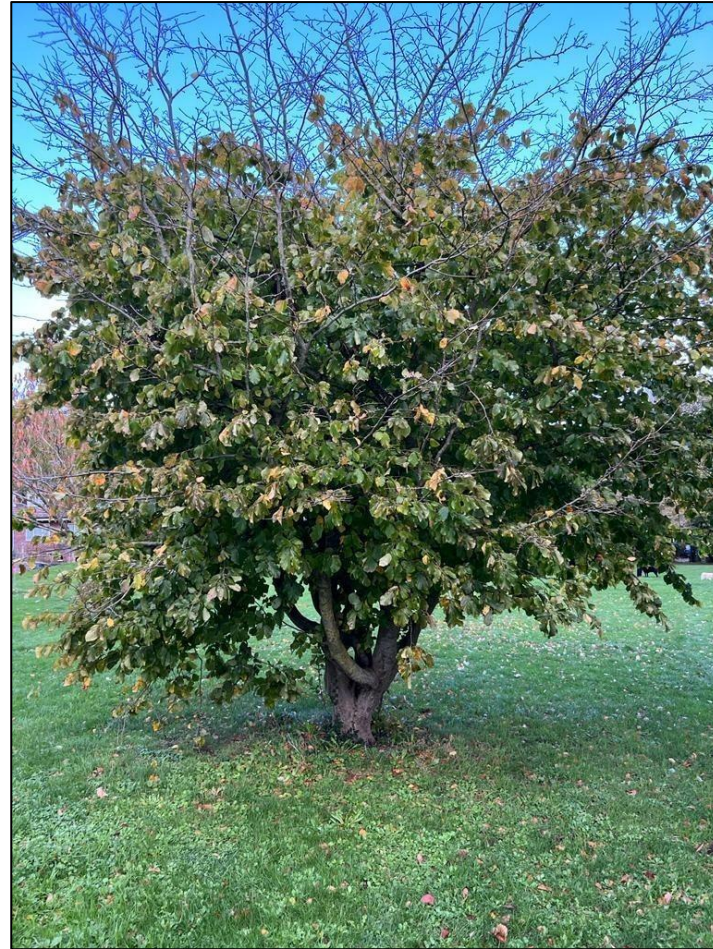
Photo 26 _ Low crown on Persian Ironwood tree (T19)

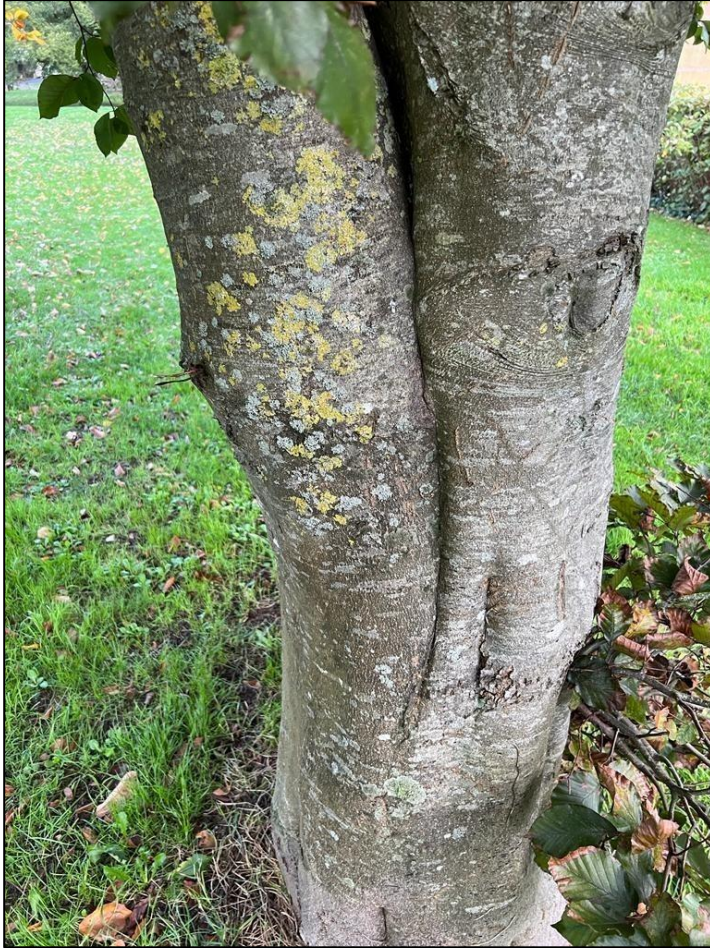
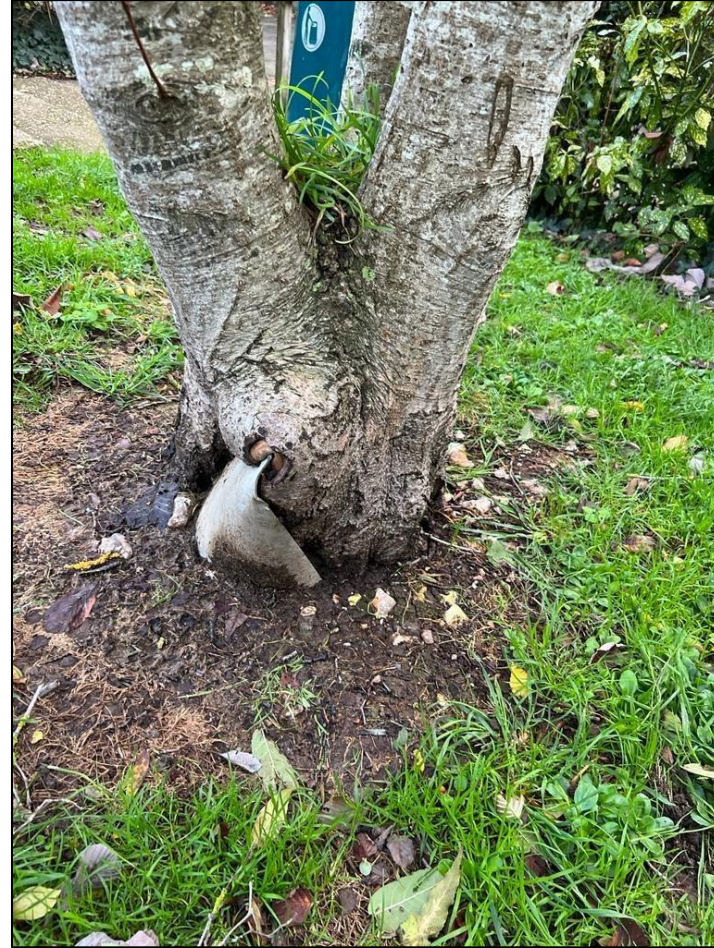
Photo 27 Compression fork on beech
union and old guard on lime tree (T26)

tree (T20)

Photo 28 – vegetation in main

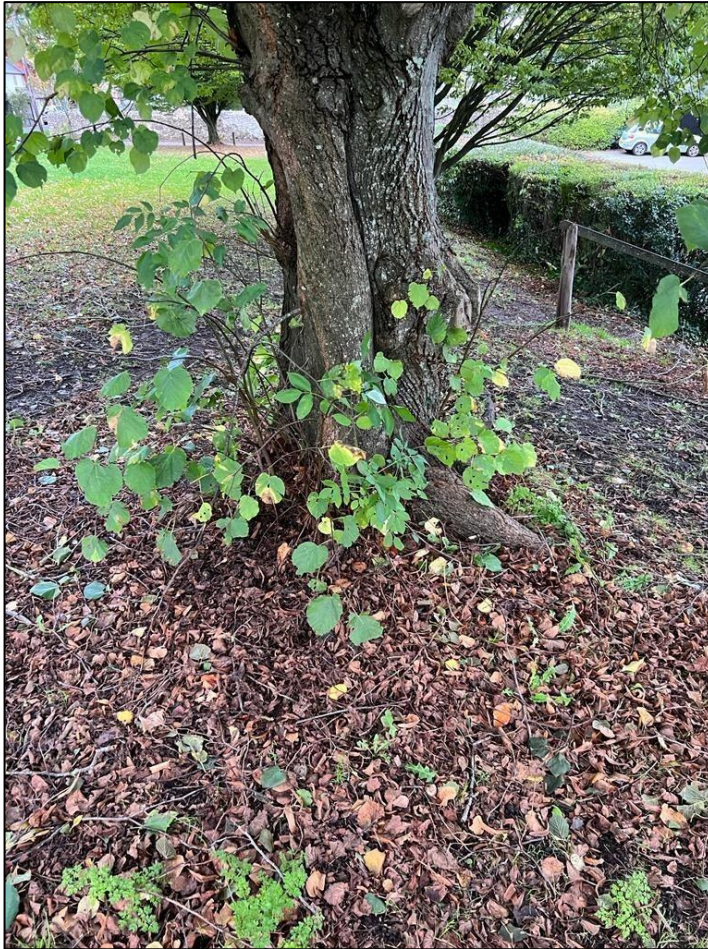
Photo 29 Basal suckering on lime tree (T28)

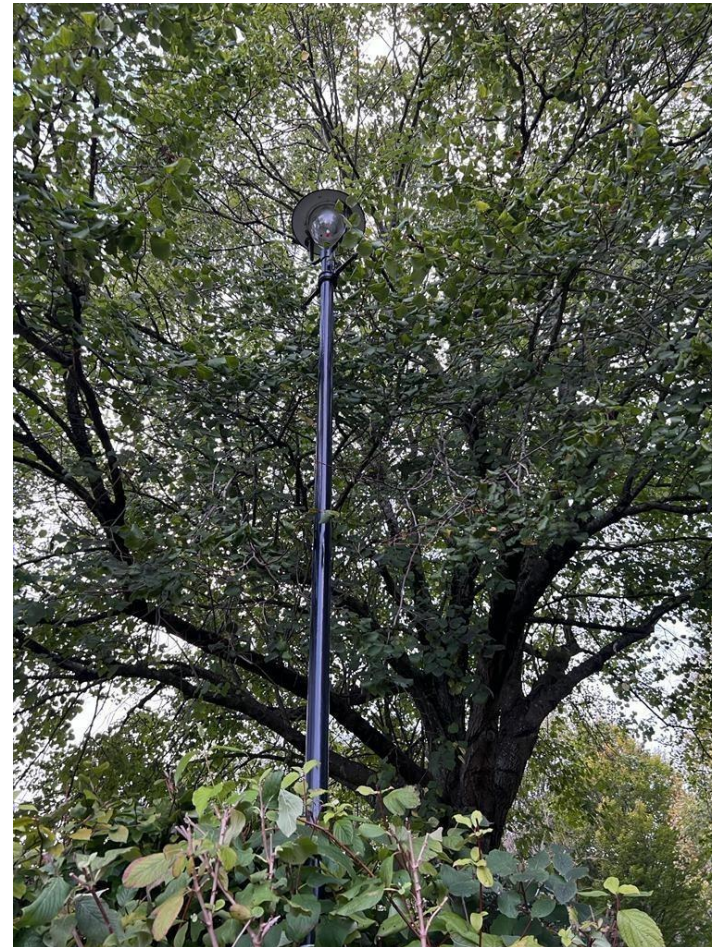
Photo 30 – Lime tree (T28) branches impeding street light

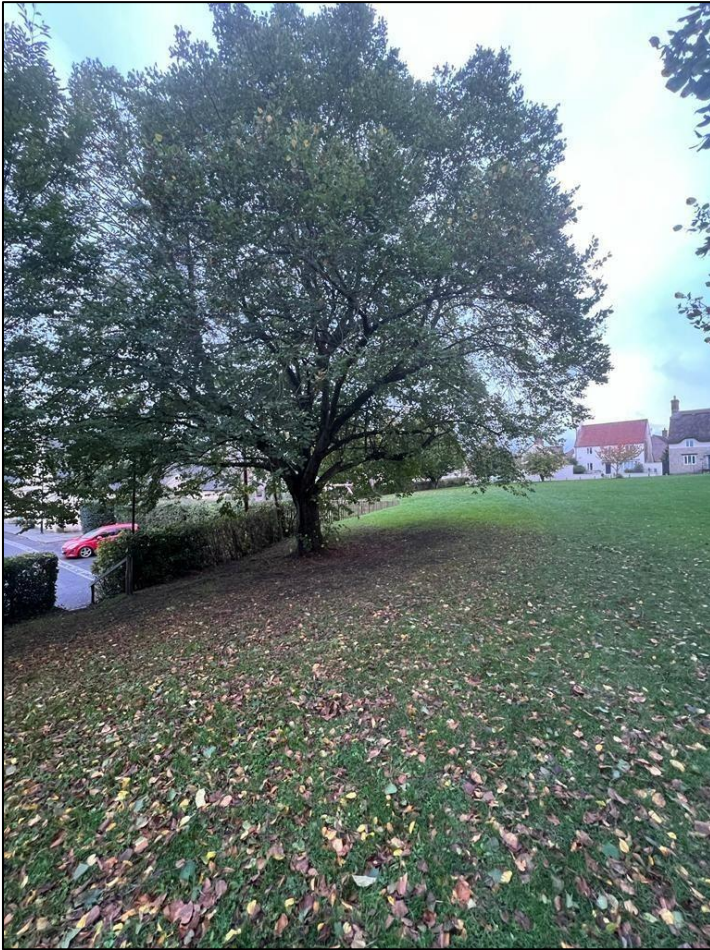
Photo 31 low crown over green of lime tree (T28)

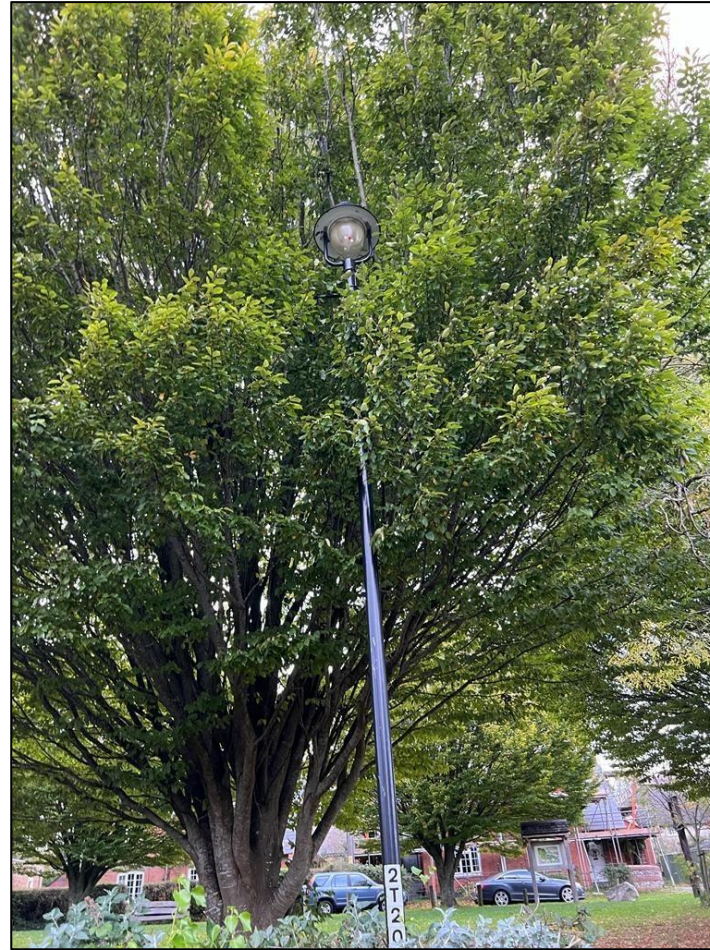
Photo 32 – Hornbeam tree (T31) branches impeding street light
