Visual Inspection and Health Appraisal

Trees

Adjacent to Stratton Playing Field/Play Area
and
On the Village Green

22nd November 2022

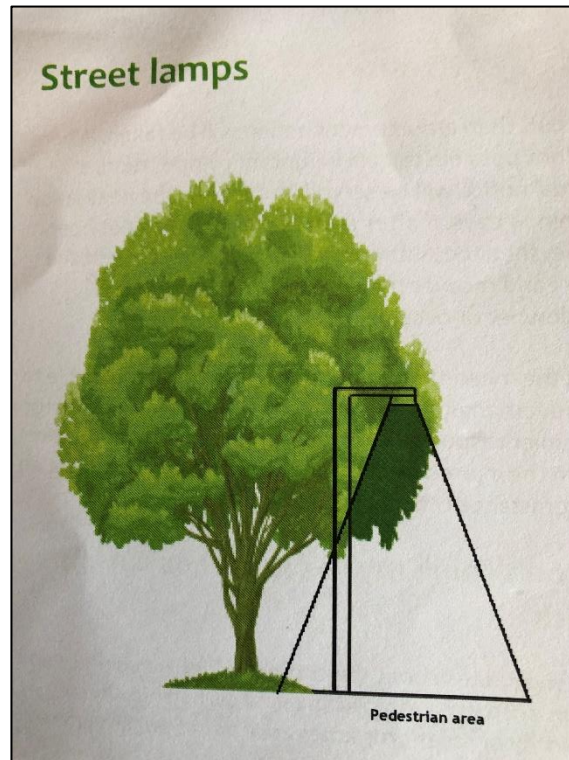
Plate 1 – County Council guidance on clearing around a street lamp

Dorset Highways further stipulate that street lamps must be clear of vegetation, ensuring that a tapered clearance is also obtained to ensure that the lamp can illuminate an area below it. It is therefore recommended that the Street Lamp is cleared similar to the guidance shape given in Plate 1 below, which was taken from Dorset County Councils guidance
